J-2296-07

April 28, 1999

Re: First Quarter 1999 Performance Report
Avery Landing Recovery System

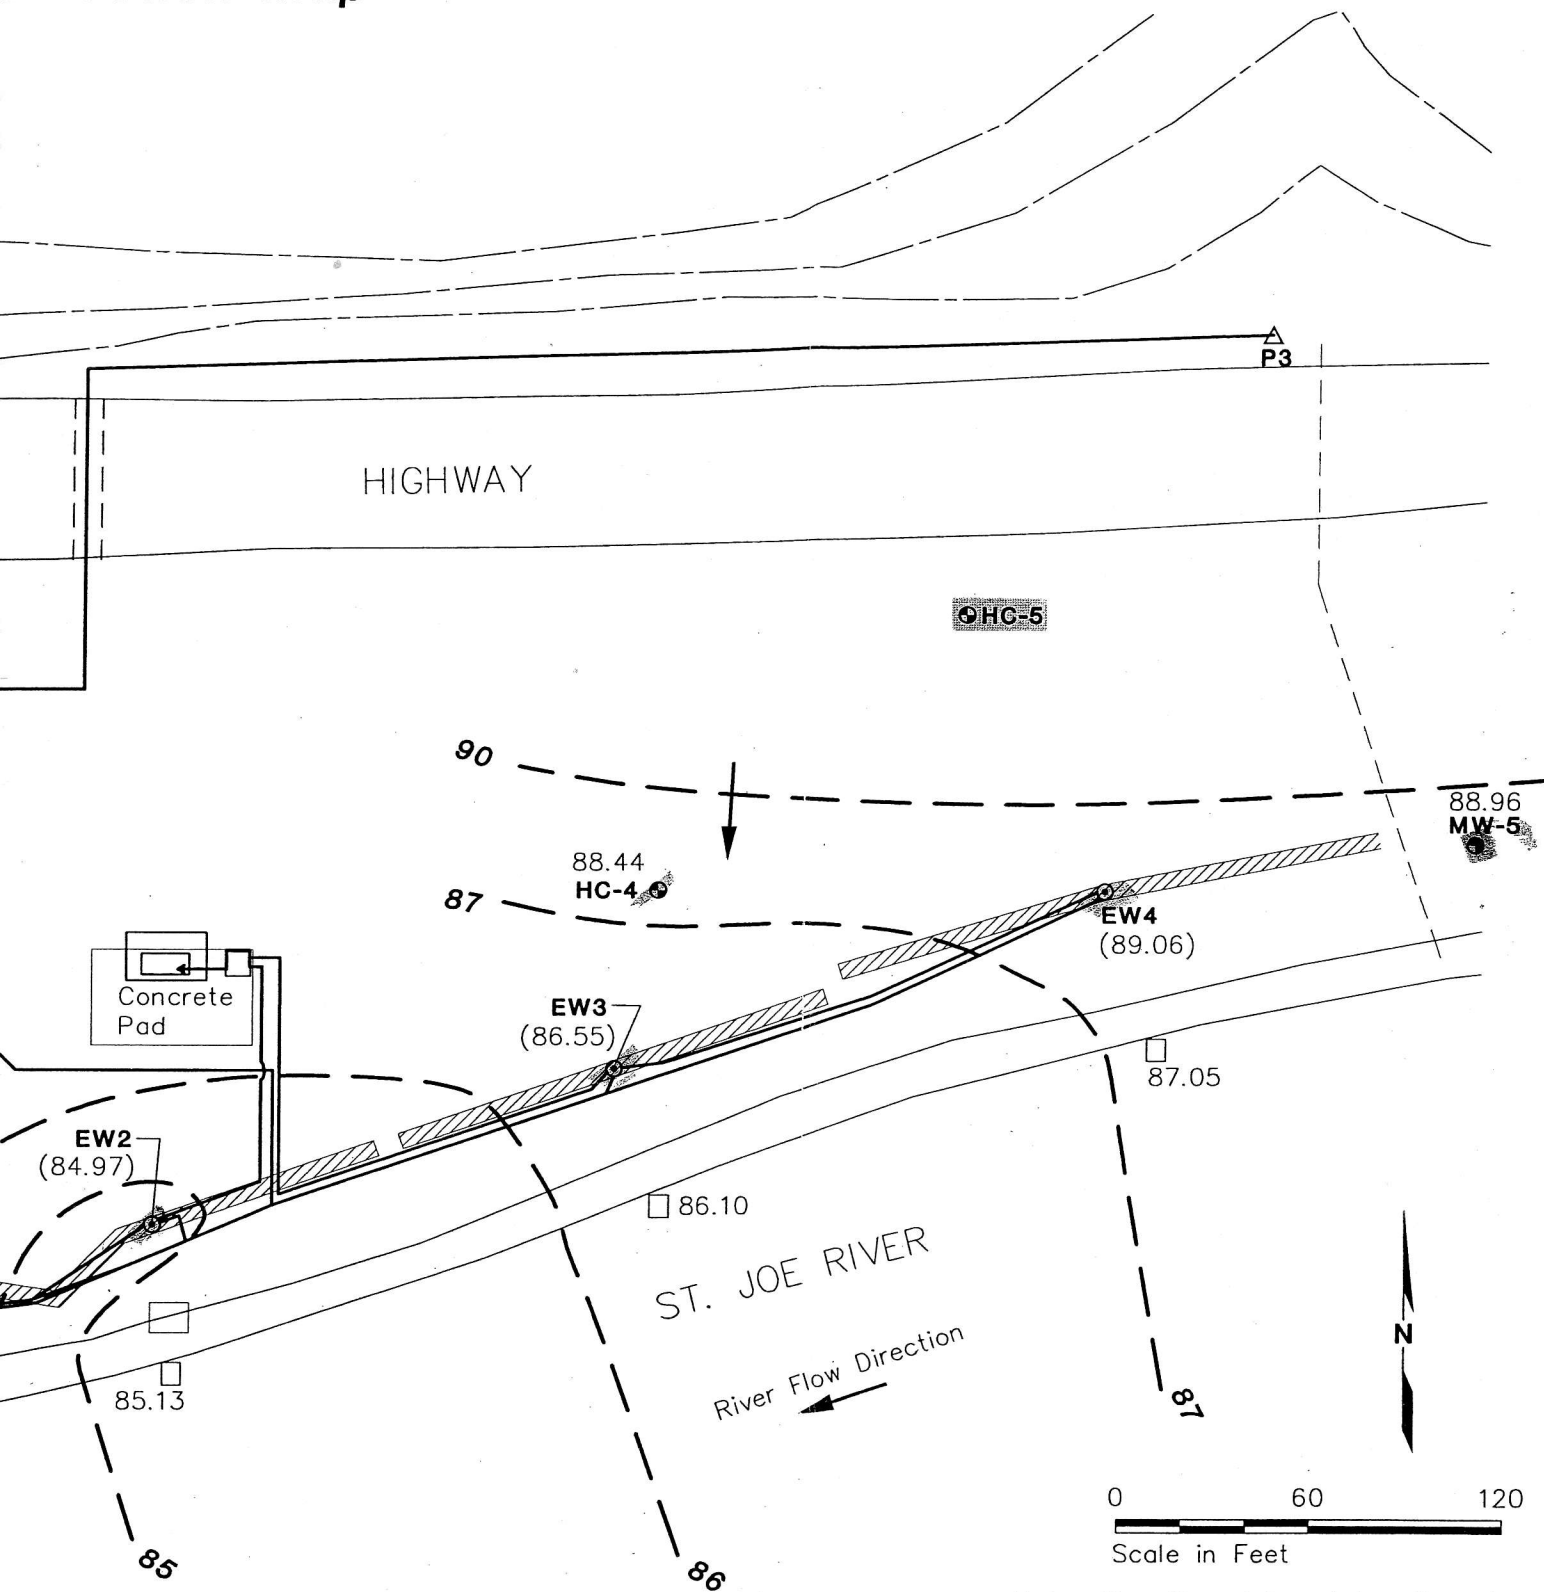
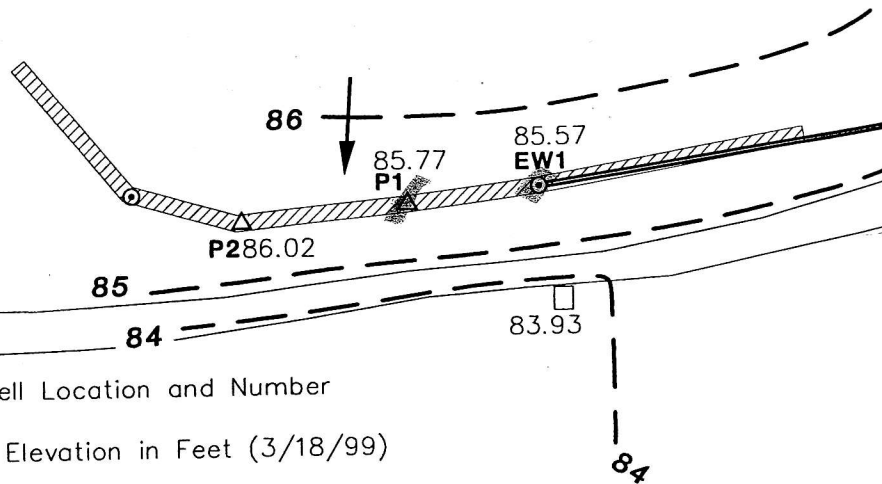
Figure 1

During the March 18 site visit, the extraction system was not maintaining a water table depression along the St. Joe River. The extraction well operation was observed as follows:

- ▶ EW-1 is no longer in use, as described in the 1998 Annual Report;
- ▶ EW-2 was operating and maintaining groundwater capture as indicated on Figure 1;
- ▶ EW-3 was operating, but was not maintaining groundwater capture. This could be the result of high groundwater flow due to spring runoff; and
- ▶ EW-4 was not operating during the March 18 site visit because of pump failure. During the site visit on April 6, 1999, the motor and pump had been replaced, and EW-4 is currently operating.
